Aim of this investigation Does the action of the water lead to any negativ changes in the performance of plain bearings.

Test description and results:

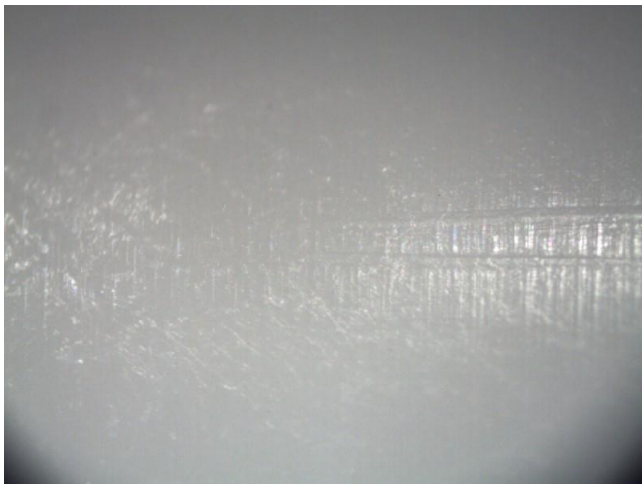
iglidur® A180 before

With the aid of the microscope (40-fold magnification) no erosions or other surface changes could be detected.

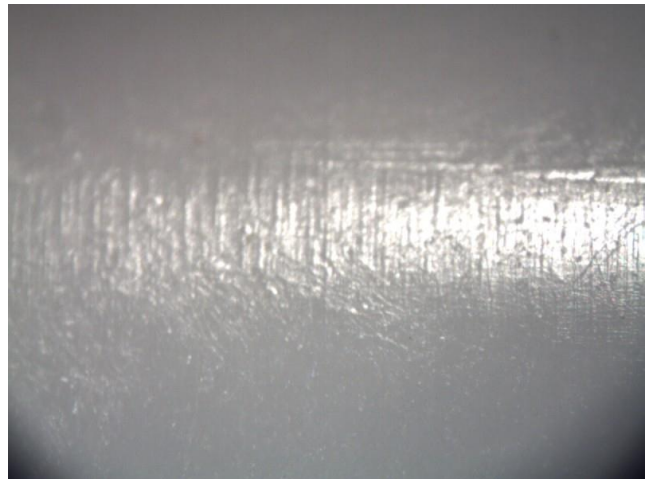
iglidur® A180 after

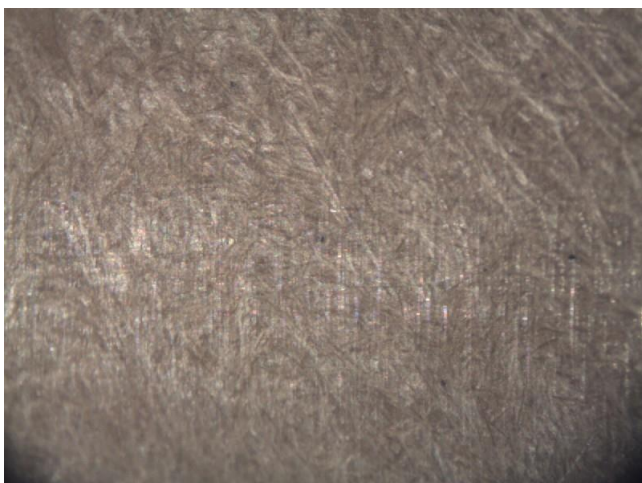
iglidur® H4 before

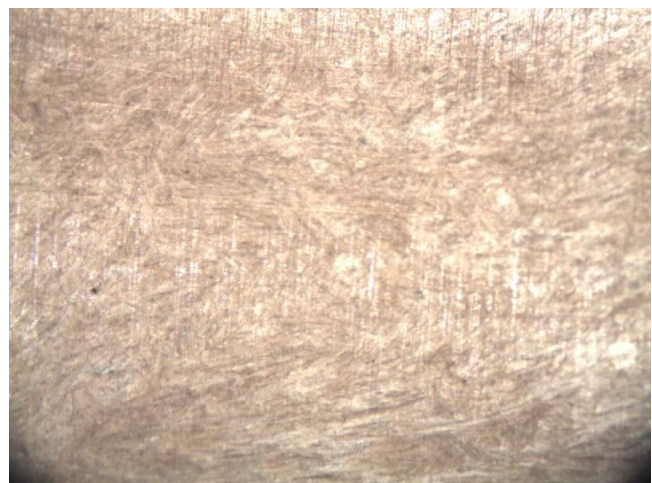
iglidur® H4 after

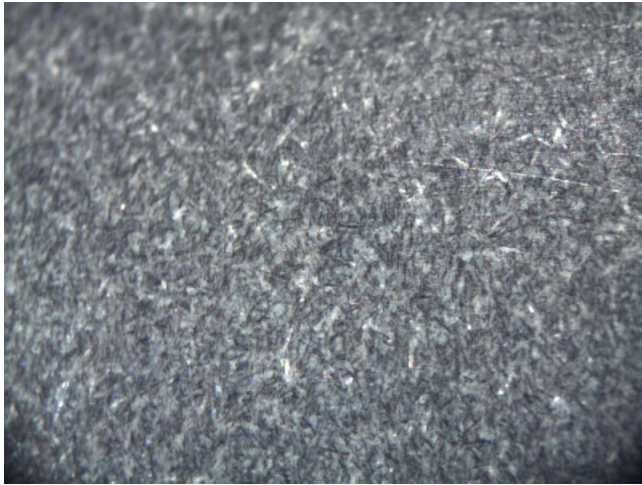
igidur® H370 before

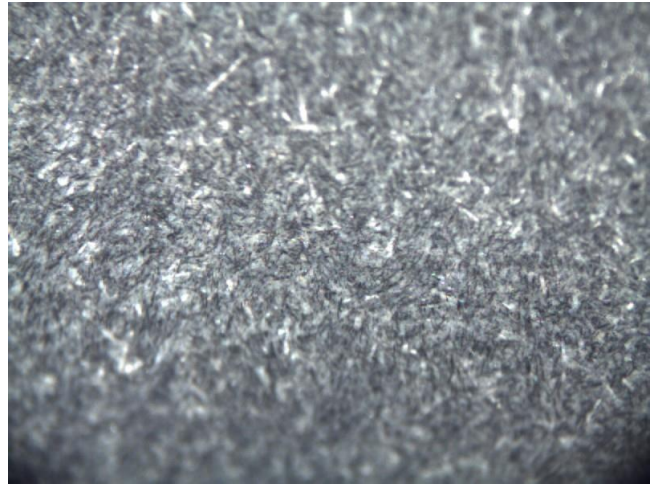
igidur® H370 after

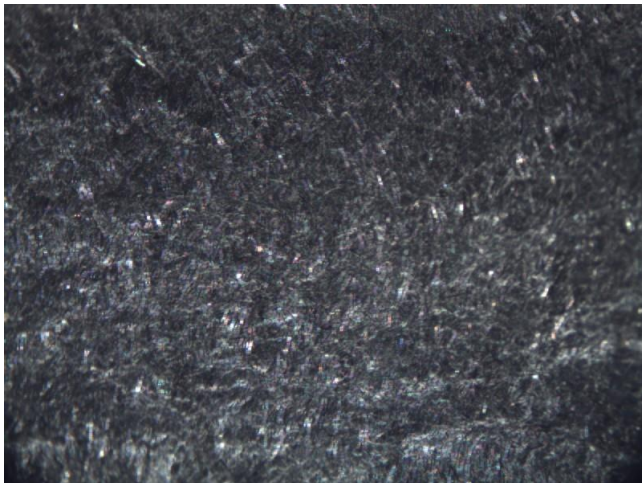
igidur® UW before

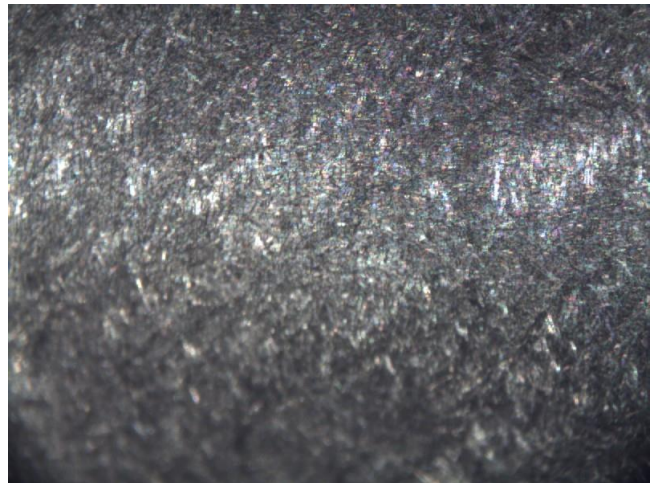
igidur® UW after

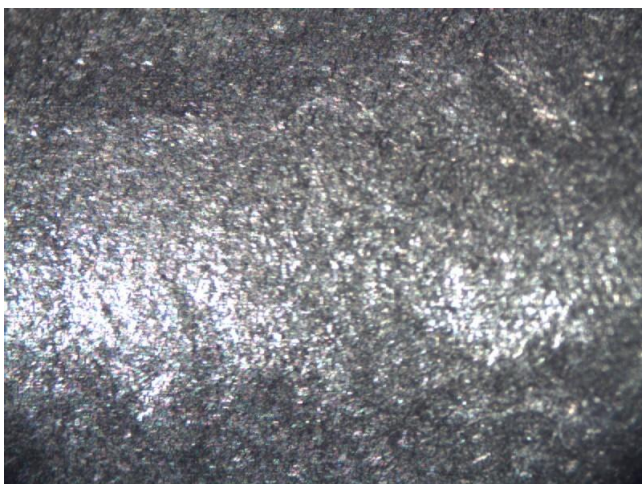
igidur® UW500 before

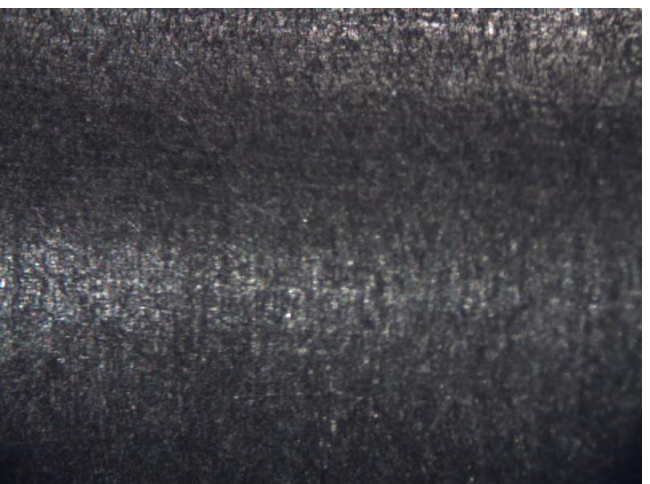
igidur® UW500 after

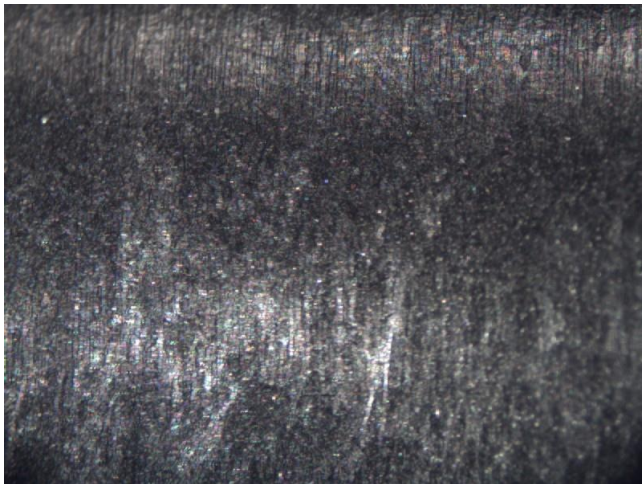
igidur® X before

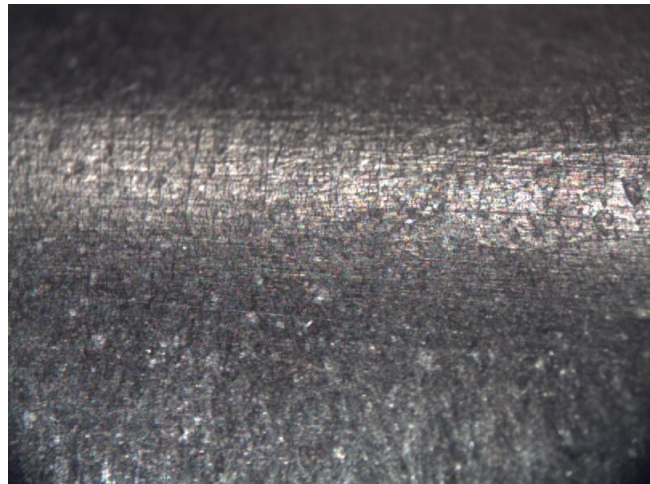
igidur® X after

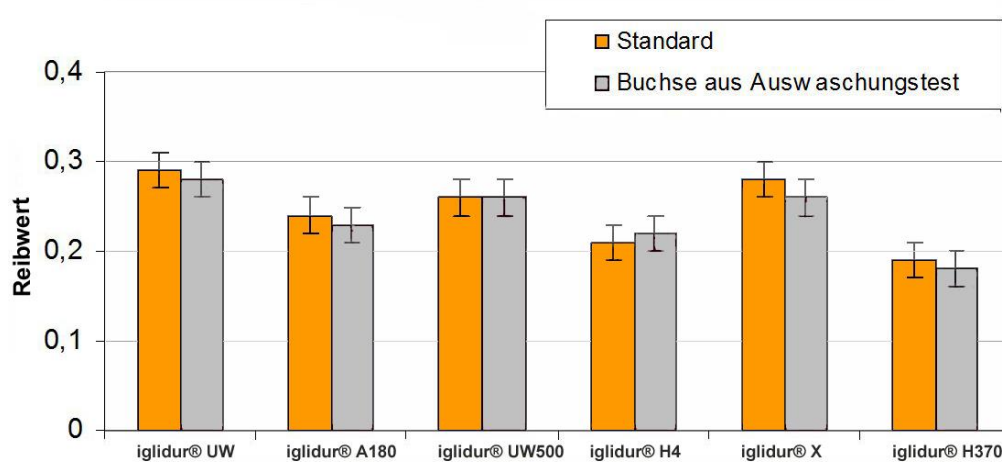
Furthermore, the coefficients of friction of the materials were examined. No significant differences between relatively new parts and those that were in the "erosion test" could be determined.

Friction coefficient comparison; $p=0.7$ MPa; $v= 0.15$ m/s; Cf53 shaft
