## Test Intention:

In test 4009 we want to investigate the lifespan of a CF THERMO.K.001 on the short way.

Series / No: CF THERMO.K

Installation type: horizontal, short way

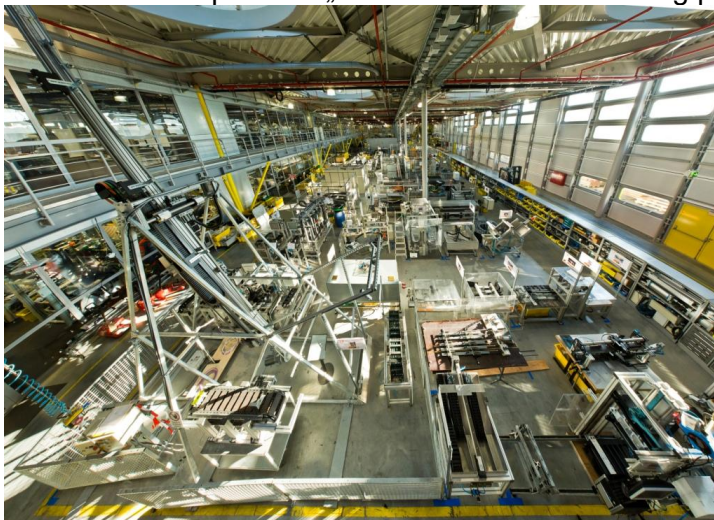
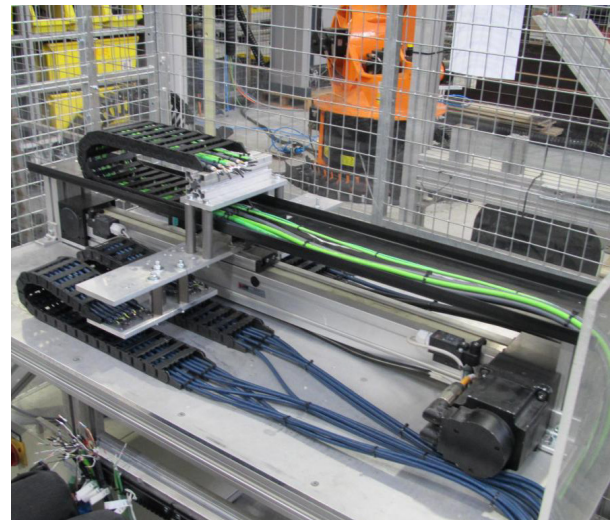
This test is built up on the „kleine Bahr“. The following picture shows the test structure:

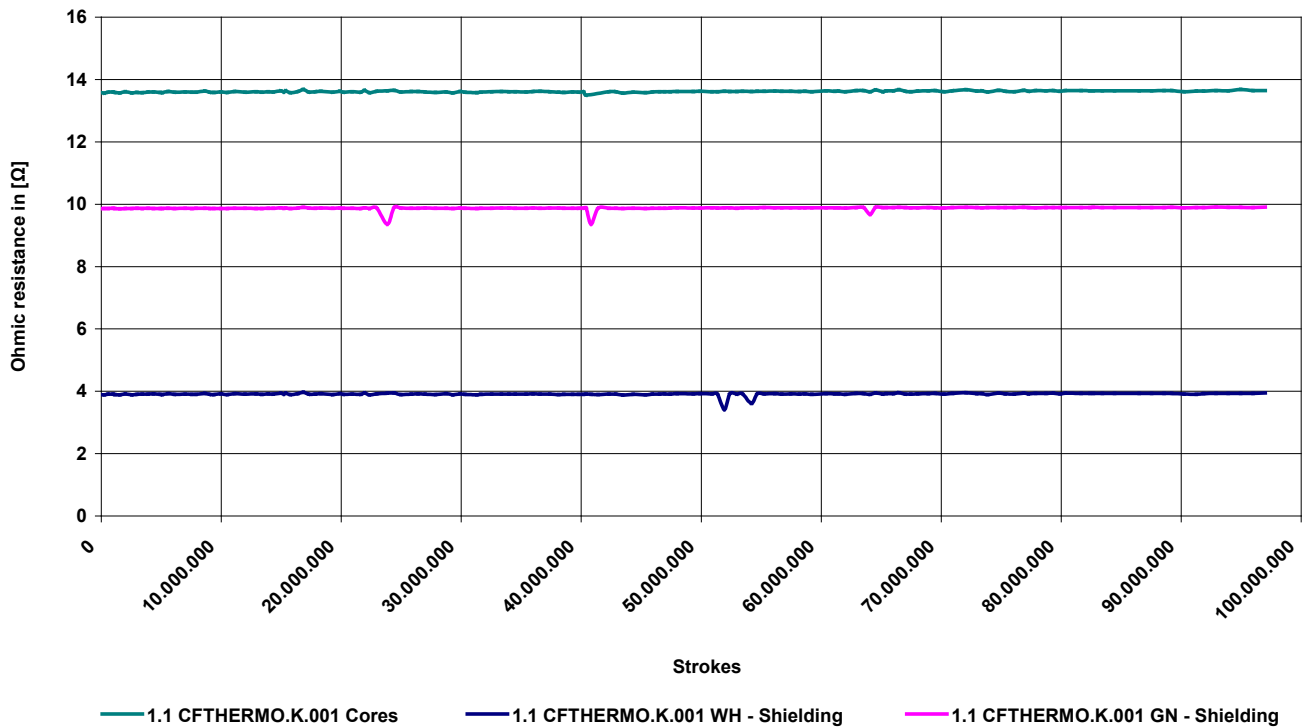
The following diagrams show the trend of the ohmic resistances during the test:

Trend of the ohmic resistances

To detect broken conductor or shielding wires we will measure the ohmic resistance of these cable elements. The cores of the samples are connected in series and one core is connected with the shielding to measure the ohmic resistances.

At the 26.02.2013 we made visual check and measured the ohmic resistance after 97.006.936 strokes. All parameters were still in a good condition. The test is still running and we will demount the cable when the ohmic resistance is too high.
